## SHORT COMMUNICATION

### Cross-Threaded Internal Dental Implant Surface- A technical note!

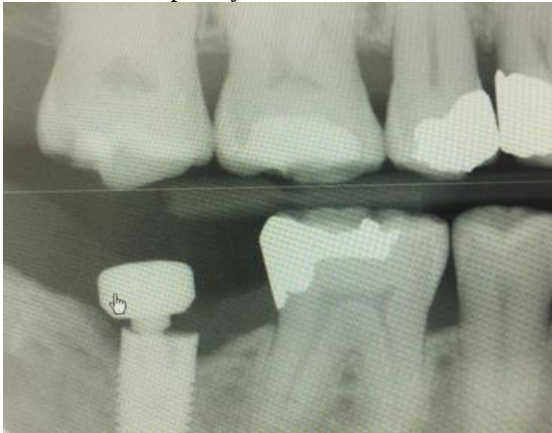
Fig 1b. Healing abutment attempted but distally inclined and unable to be seated completely.

A dilemma arose debating the options for providing a definitive restoration. After analyzing multiple management options, we decided to use an innovative re-tapping tool manufactured by the Implant company to handle such complications. A Zimmer OMNI/ SPL TAP 0493 (*Zimmer Dental*) specifically designed and created for re-tapping or re-threading the internal surface of Tapered Screw- Vent Implant. This special tool had to be requested from *Zimmer Dental* to salvage the osseointegrating endosteal implant. The tool was similar to a hand driver and was inserted into the internal thread surface and seated at appropriate angle in line to the thread pattern. A clockwise 1/8<sup>th</sup> of a hand turn was performed, followed by copious irrigation of saline and adequate suction to remove the debris from the internal implant surface<sup>1</sup>.

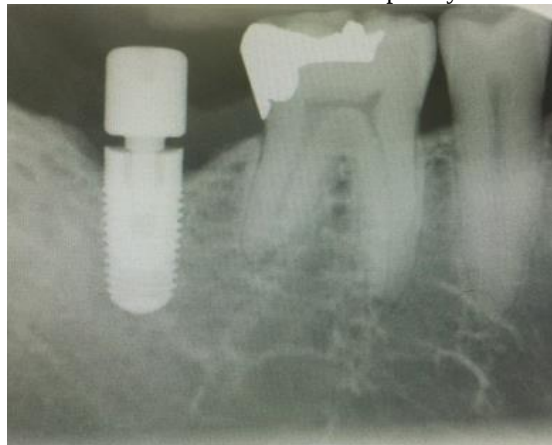
Fig 1c. Taller healing abutment attempted and unable to be seated.

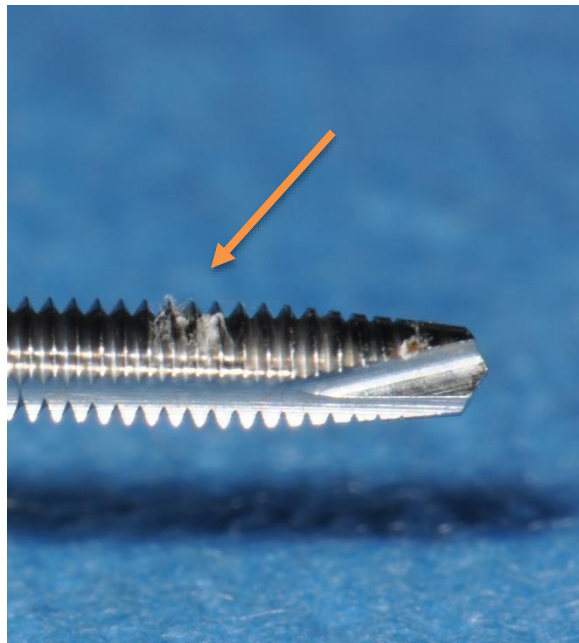
Fig 2b. Magnification (arrow) depicting the area on the Zimmer OMNI/ SPL tap where the successful re-threading of the distorted internal thread was accomplished.

Following the completion of re-threading or re-tapping procedure, we were able to successfully seat the new healing abutment until there was no space between the implant platform and collar of the healing abutment.
